003/2021

**MANUFACTURING
FLOOR
CHEMICAL PROTECTION**

FLOOR REBUILD AND
PROTECTION
SEPTEMBER, 2019

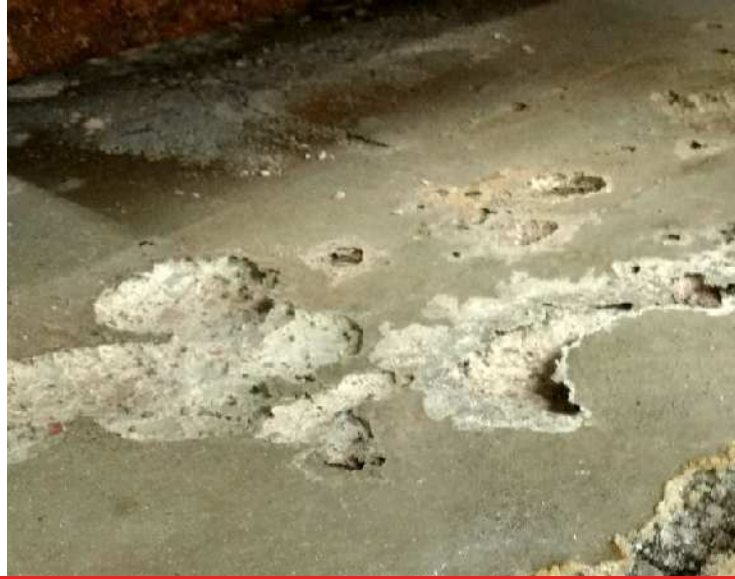
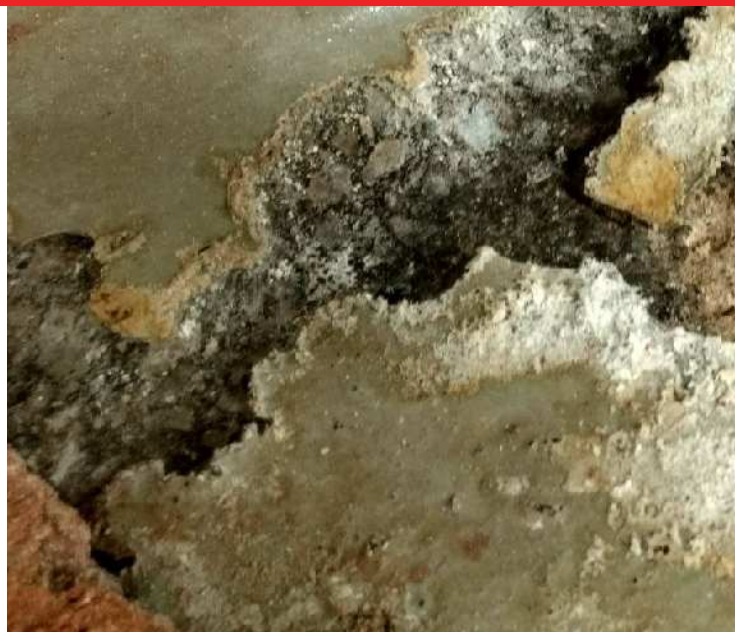
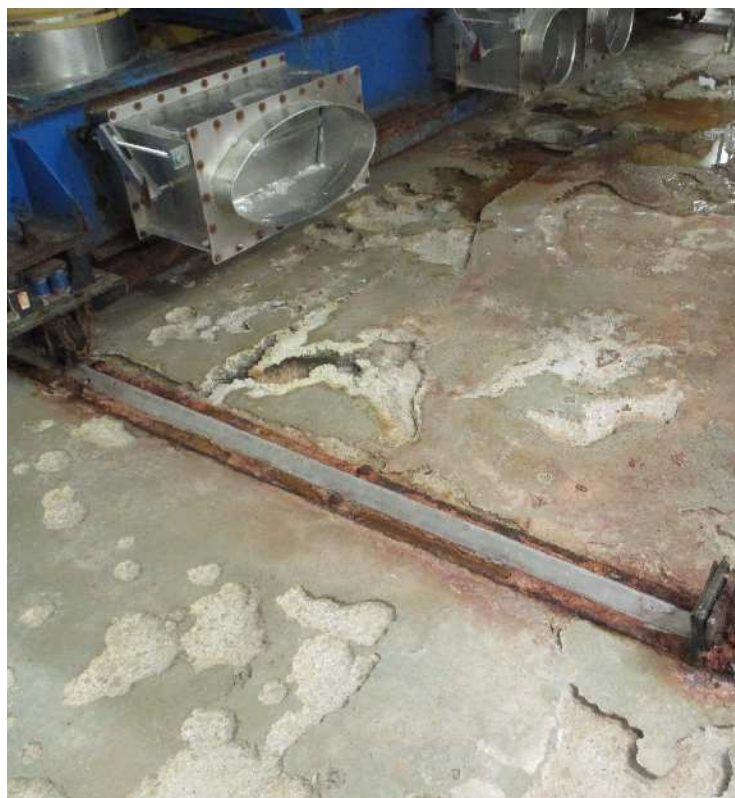
Manufacturing plant that processes Bio-based succinic acid was having issues with their floors. Dry process material of Bio-based succinic acid was being spill onto the concrete floor and during floor washing operations, water activated the acid and this one started to attack the concrete.

The damage to the floor was worse at areas where there were pockets or cavities or where the floor coating had been compromised. The concrete succumbed, leaving large holes in the floor that perpetuated more damage for each subsequent floor washing activity.

The asset owner was planning on chipping all loose concrete from the floor before patching all damage to regain the proper elevation and finish. The previous coating did not provide any chemical protection and was not effective at preventing the acid from attacking the concrete. The floor needed to be re-coated with an acid proof coating that was also able to take walking traffic and the occasional abrasion from hand tools, scraper, brooms, etc. They wanted a floor coating able to last many years in this harsh environment.

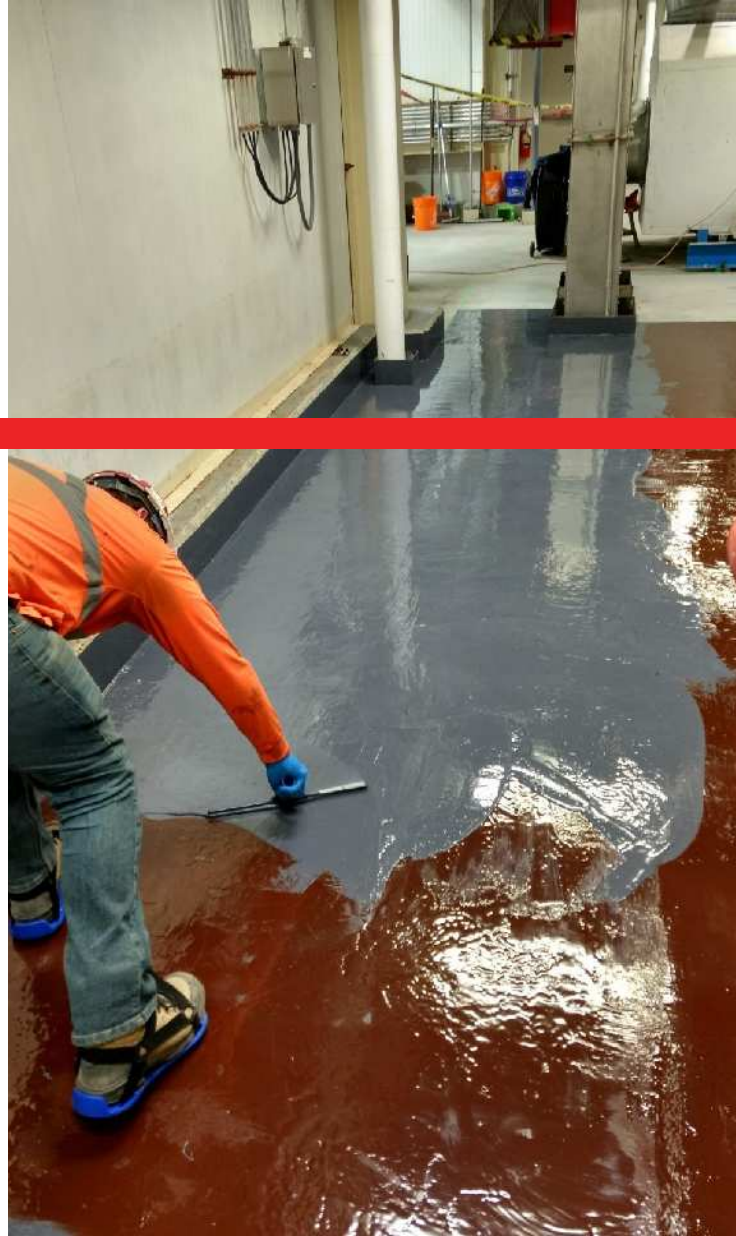
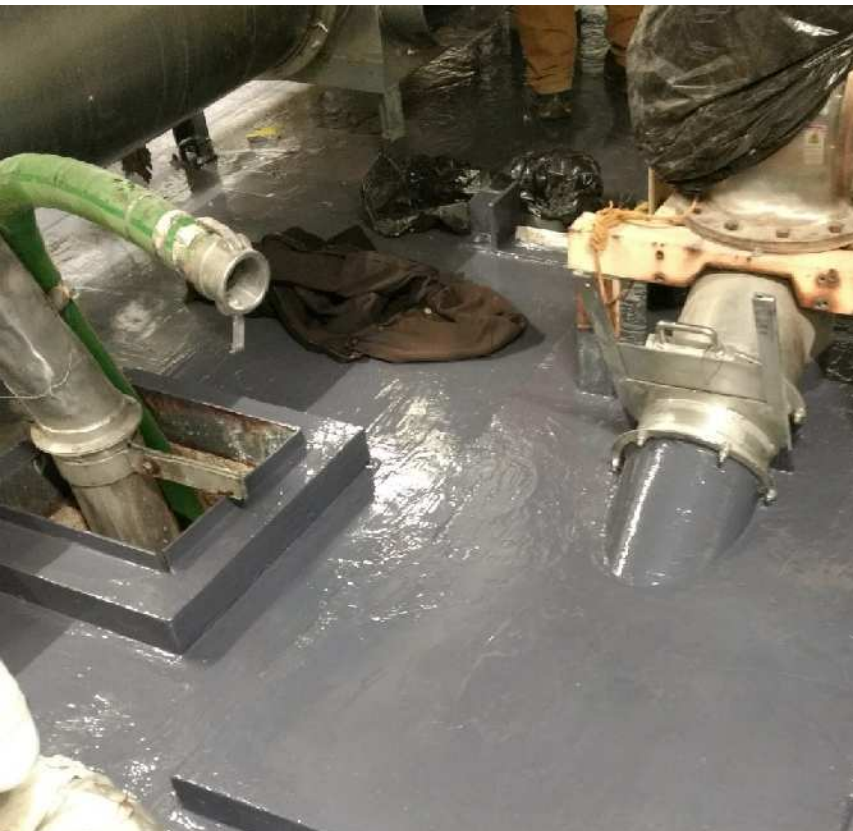
The damaged concrete was washed and decontaminated. Missing concrete areas were refurbished and smooth out. 2 coats of Belzona 4311 (Magma CR1) were applied to prevent future deterioration of the concrete via chemical attack.

Belzona 4311 (Magma CR1) was specified as a high-performance barrier coating with excellent chemical protection. The customer had interest in performing further tests, so we provided small brick samples coated with Belzona 4311 (Magma CR1). The coated samples were immersed in Succinic acid for 1 month. The coating did not exhibit any sign of deterioration. The customer was pleased with the performance of the coating and decided to proceed.
