BELZONA[®]
GREAT LAKES

**POWER
TRANSFORMER
LEAK SEALING**

TRANSFORMER OIL LEAK
MARCH, 2021

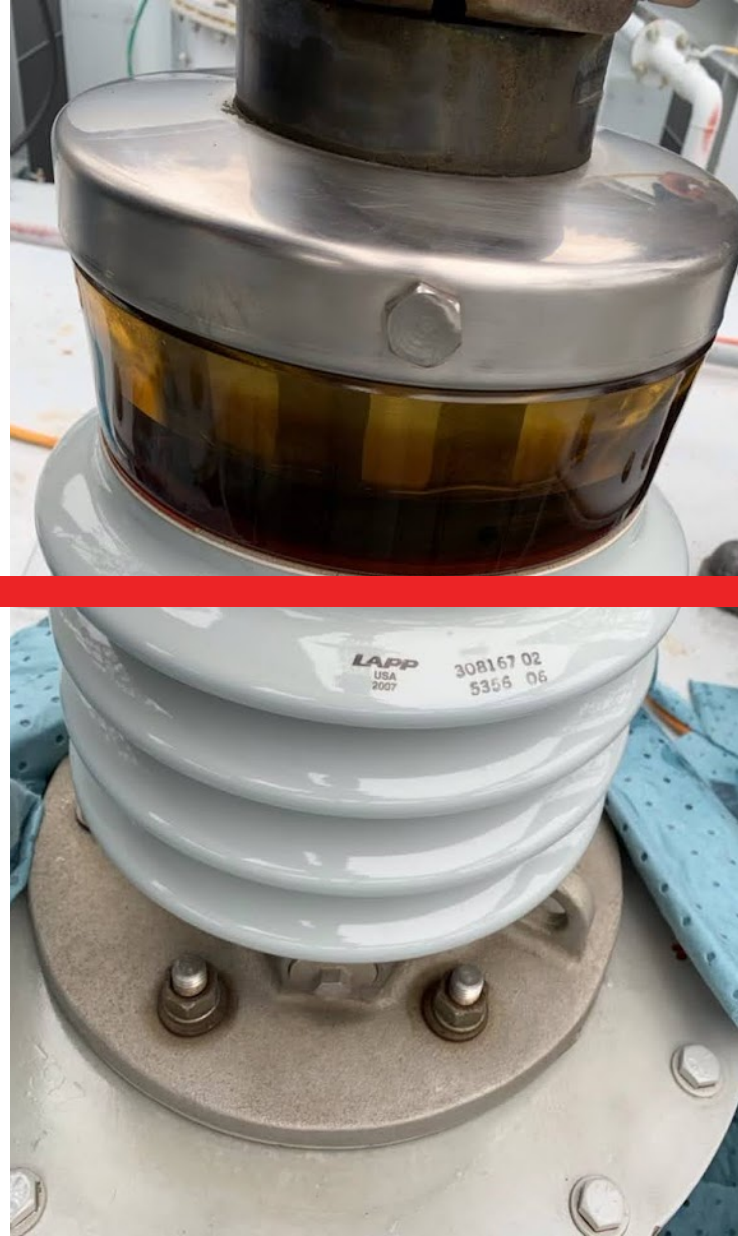
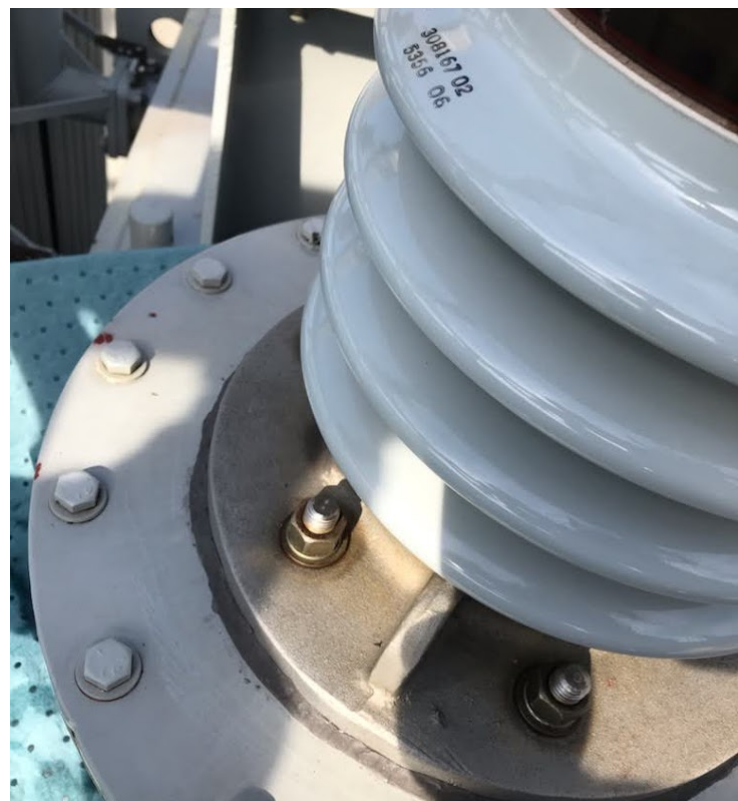
A transformer station in Northwestern Ontario, was having issues with the bushing of a transformer that was leaking oil. The leaks were causing an environmental hazard as well as the inconvenience of having to top up the oil in the transformer every couple weeks. There was no way of sealing these leaks, welding was not an option due to the environment.

The surface was first cleaned with Belzona 9111 (Cleaner Degreaser). Then, the leaks were first stemmed using Belzona 9611 (ES-Metal). The surface was then roughen up with hand tools.
